Inspection Report for
Claytor/Ingersoll House
Old Bethlehem Pike, Spring House, PA

CLIENTS: Lower Gwynedd Township

INSPECTION DATE: December 05, 2022

Inspector: William Kibbel III
Pa Compliant, NJ License #24GI00038400

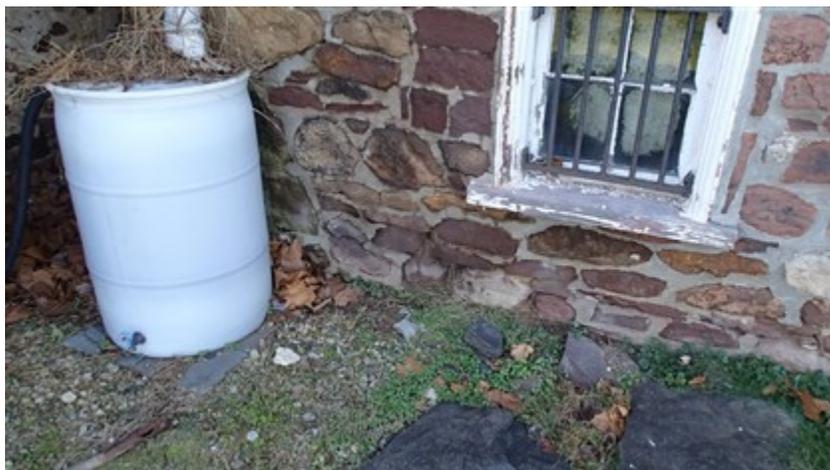
The exterior walls are constructed of stone. The coursing of the stone work shows the house was built in at least three sections, as well as several other alterations, including blocked up window and door openings and reduction of the size of some openings. Most of the stone work is in satisfactory condition. There are a few spots of repointing needed, mostly near grade.

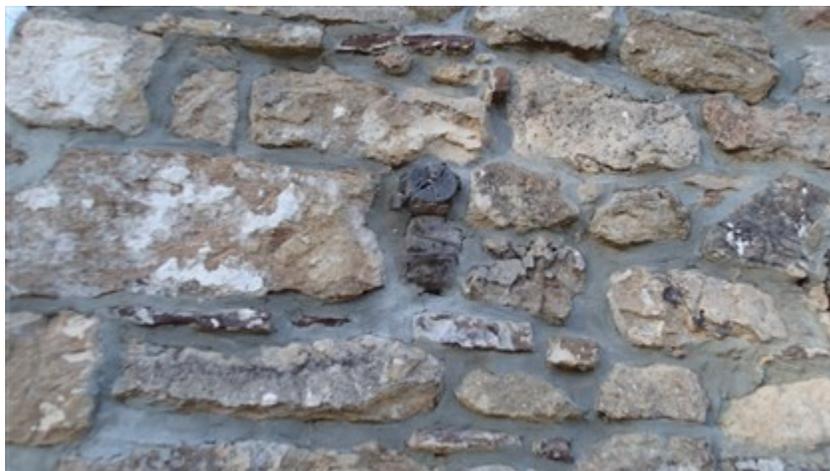
There are some wood blocks within the stone work for previous accessories that have been removed, including a pent roof. This wood needs to be regularly treated to prevent deterioration.

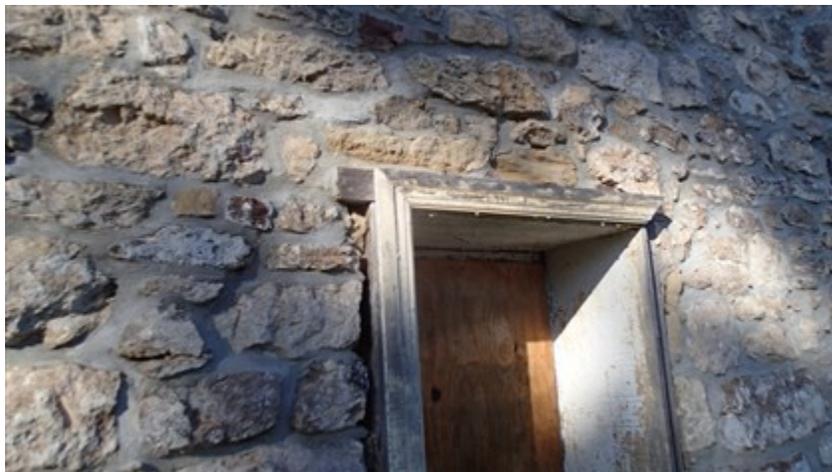
The trim around windows and doors, roof edges and overhangs are painted wood. There are areas of deteriorated wood that needs to be removed and replaced.

Some of the wood has many holes, likely from carpenter bees.

There are many areas where scraping, priming and painting are needed at this time. Have an experienced carpenter remove and replace all damaged and deteriorated wood and then scrape, paint and caulk where needed.

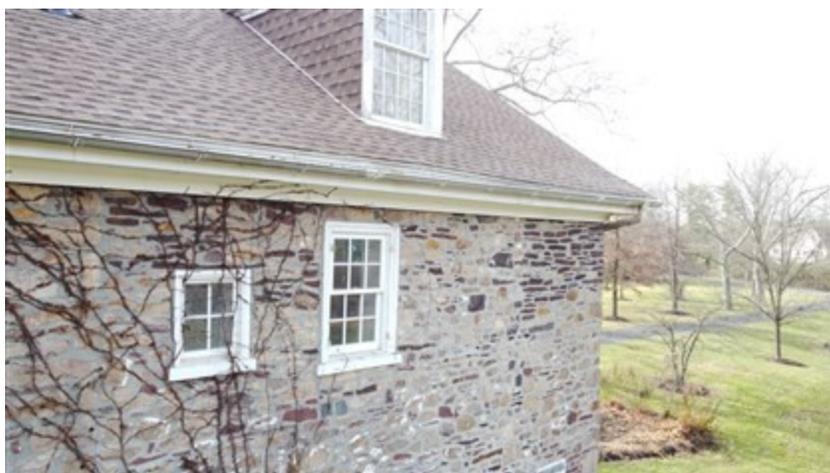
Half-round aluminum gutters are installed. Both the front and rear gutters only drain through a single downspout. Due to the amount of surface area collecting water on the roof, I recommend each gutter have an additional downspout added to the opposite end.

The gutters should then be repitched from the center to each of the four downspouts.

Be sure all downspouts always discharge away from the foundation and the gutters are kept clear of debris at all times.

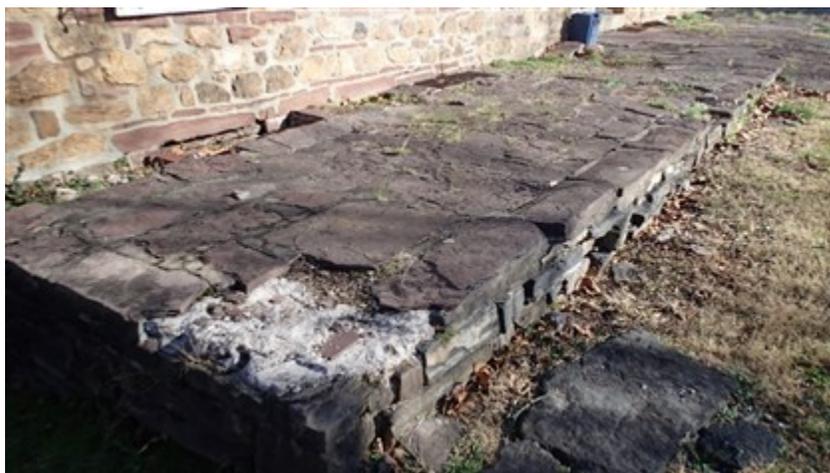
The front and rear stone patios need repair. Missing and disheveled stones at the patios and steps need to be reinstalled and the stone work repointed.

I also recommend guard rails be installed at the end of the patios where they terminate well above grade. One of the exterior stone steps that should have a hand railing installed.

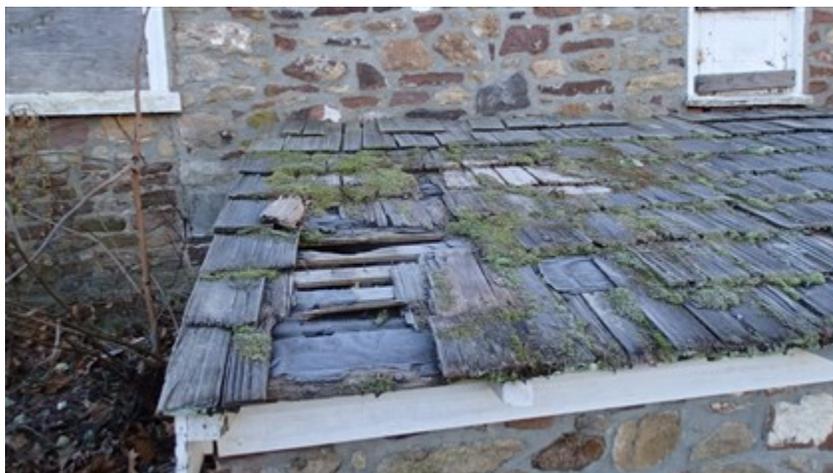
Wood shingles are installed over the lower shed roof at the left rear corner. The roof is in a deteriorated condition and needs immediate replacement.

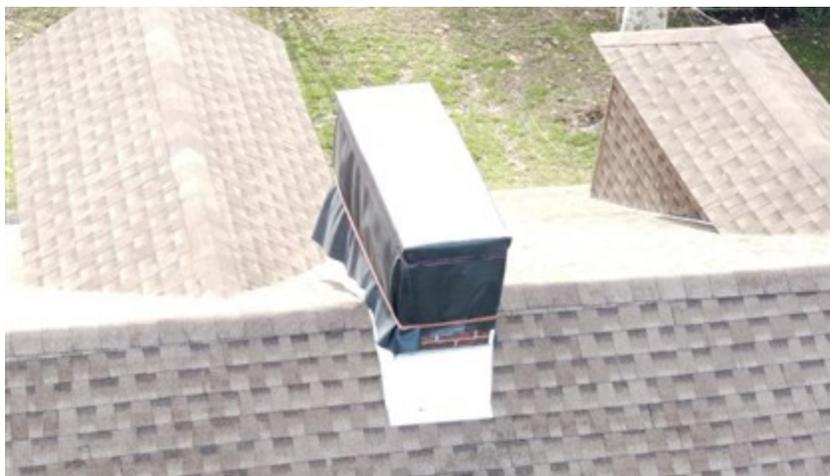
Three chimneys are constructed of stone and brick. One of the chimneys has been covered over with a membrane. Repairs are likely needed.

There are no caps installed over the flues. Screens do not keep water out. Have proper caps installed.

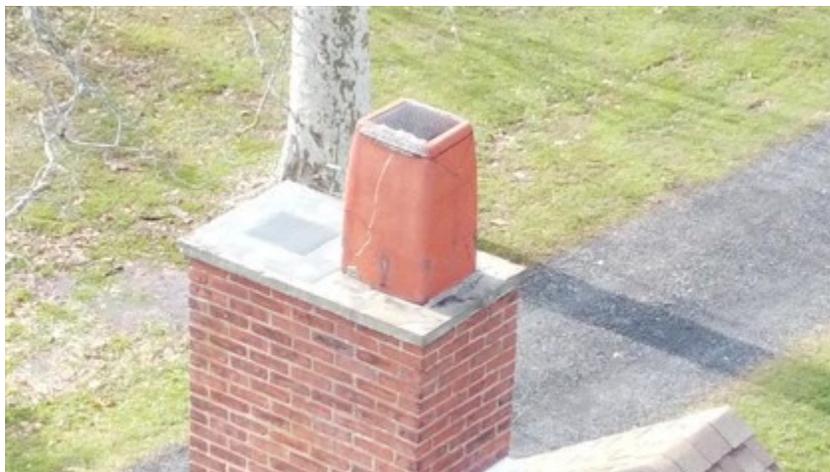
I did not find any evidence of flue lining systems being added inside of the old chimneys. From what I could see above the fireplaces, lining systems are needed before the fireplaces can be safely used.

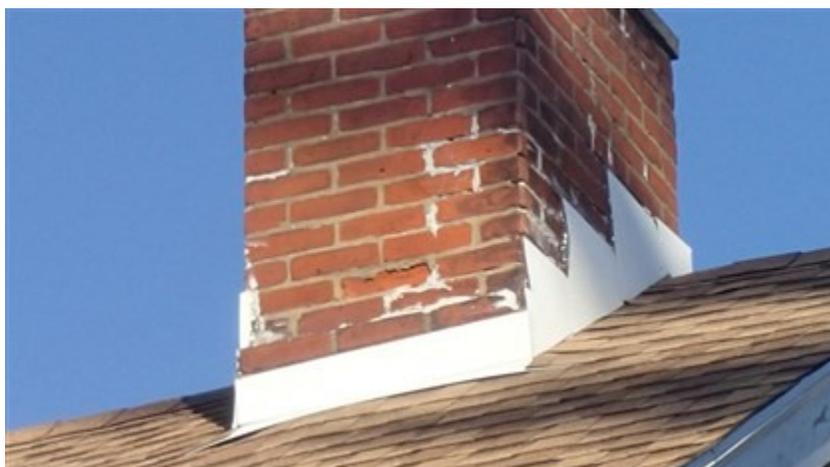
The mortar in between the older bricks is likely the improper type. It appears to be a modern Portland cement-based mortar which can actually cause damage to the bricks. Some bricks are starting to spall. (The glazed surface of the bricks are flaking off.) Have a masonry restoration contractor make proper repairs.

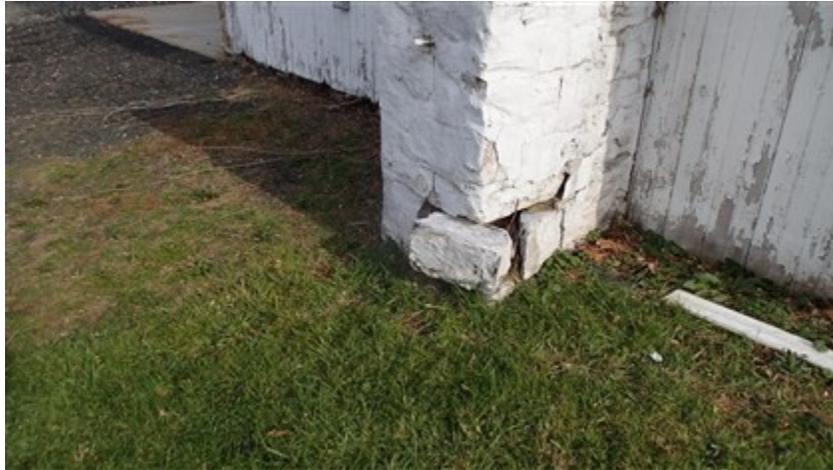
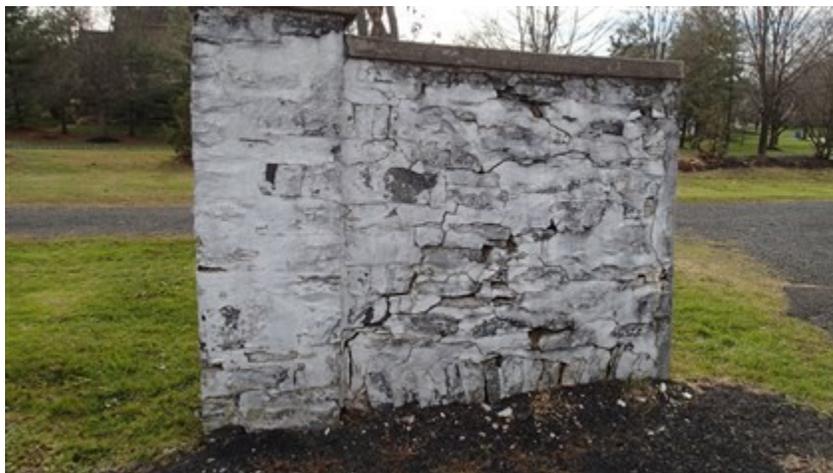
The stone wall is in need of repairs including replacing missing and displaced stones and repointing and repairing cracks.

11. Repair the stone wall between the house and the barn.

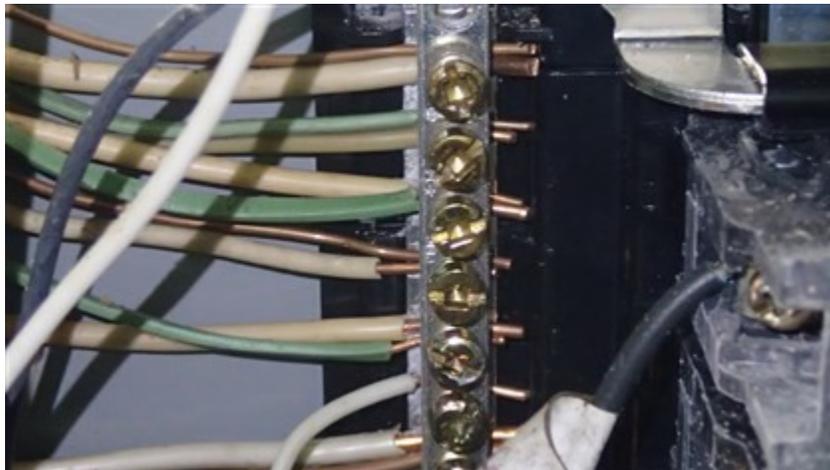
In both panels, neutral conductors are improperly doubled up with other conductors on each terminal. Each neutral conductor should be installed on its own individual terminal, not shared with any other conductor.

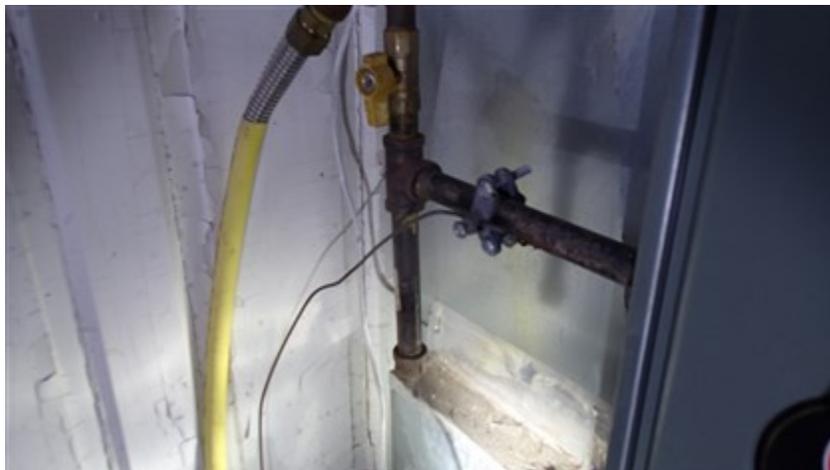
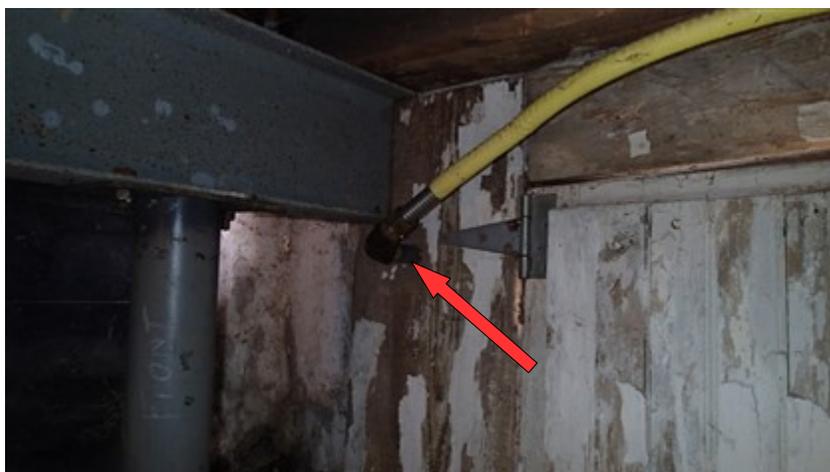
The service is grounded. The water distribution piping is not bonded to the grounding electrode system.

The gas piping also needs to be correctly bonded directly to the grounding electrode system since corrugated stainless steel tubing (CSST - with the yellow sleeve) is used for gas distribution. This direct bonding is required by the CSST manufacturer's installation instructions and the National Fuel gas Code.

The bond should be with the proper size conductor near where the gas pipe enters the building, prior to the CSST - not at the furnace with a very small gauge wire.

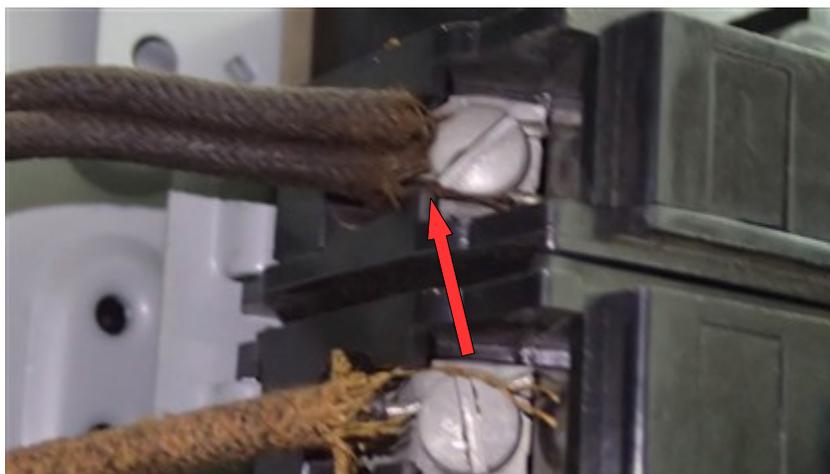
One of the breakers has two circuits installed. The terminal on this breaker is intended for only one conductor.

Have a licensed electrician make all electrical repairs, corrections and installations needed for safety.

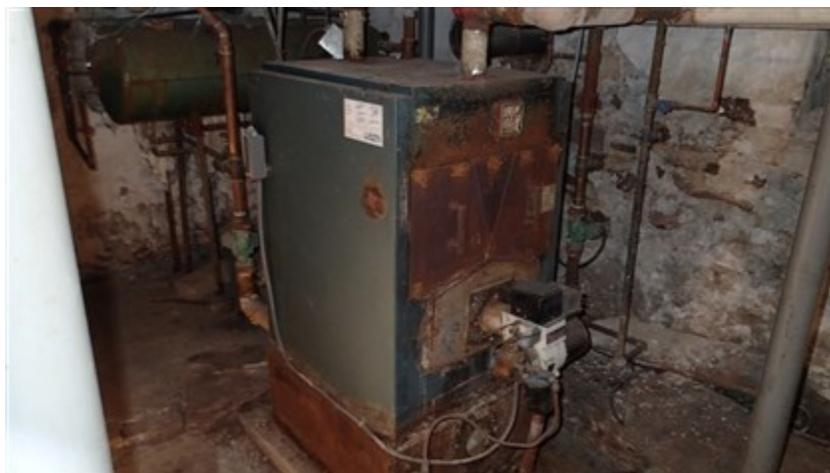
Previously, there was an oil-fired hot water heating system installed. The boiler has obviously failed and has been removed from service.

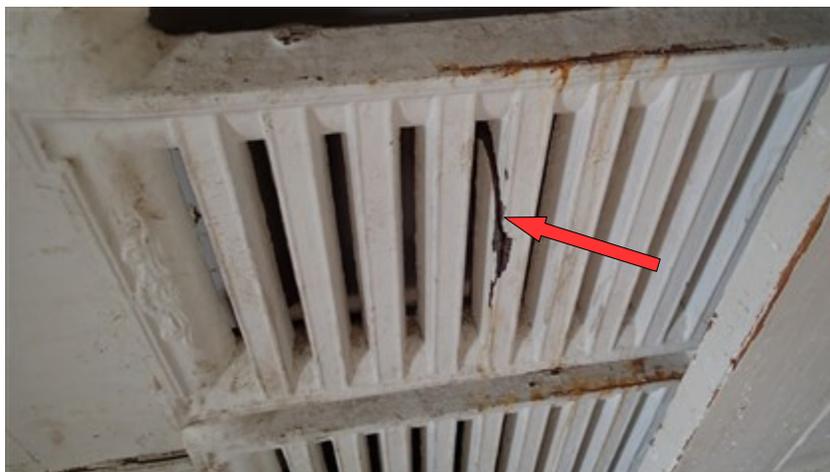
Many of the radiators throughout the building have also failed from freeze damage.

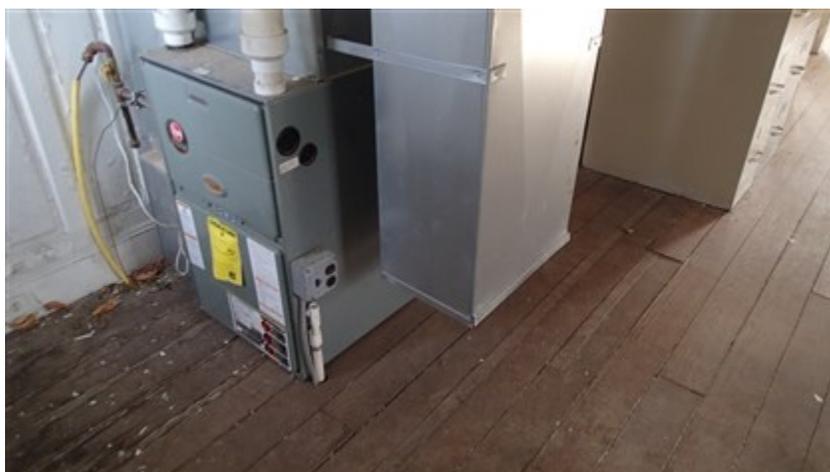
2. The primary condensate just drains into the basement instead of a proper, approved location for the discharge.
3. The electric cable to the furnace is not properly installed, secured or protected.
4. There is only one single supply from this furnace rather than distribution to individual rooms.

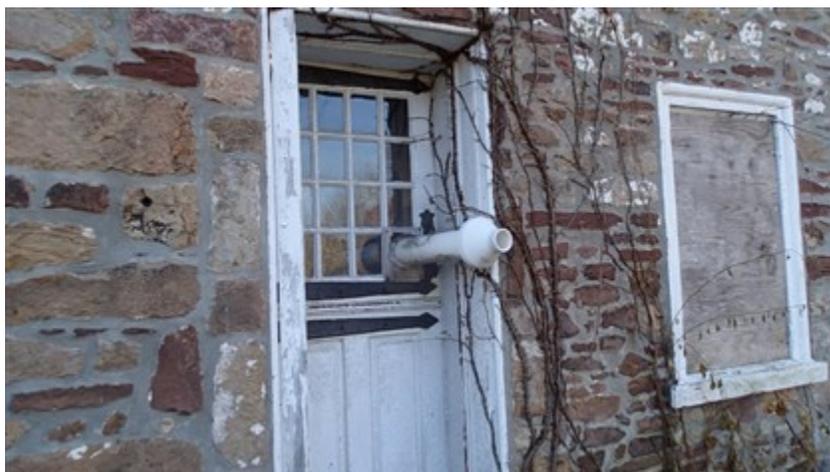
5. The intake and the exhaust vent piping was just stuck out to the exterior through a window in a door.

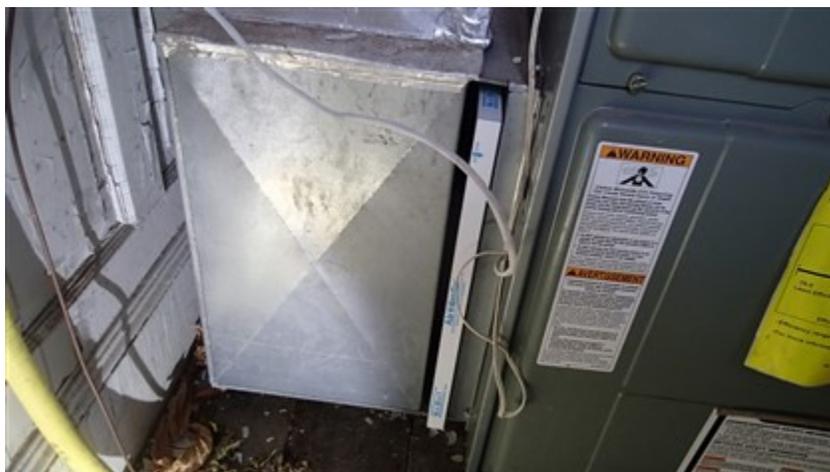
6. The cover over the filter compartment is missing.

Have a competent HVAC contractor install a proper heating system and a proper heat distribution system in the building.

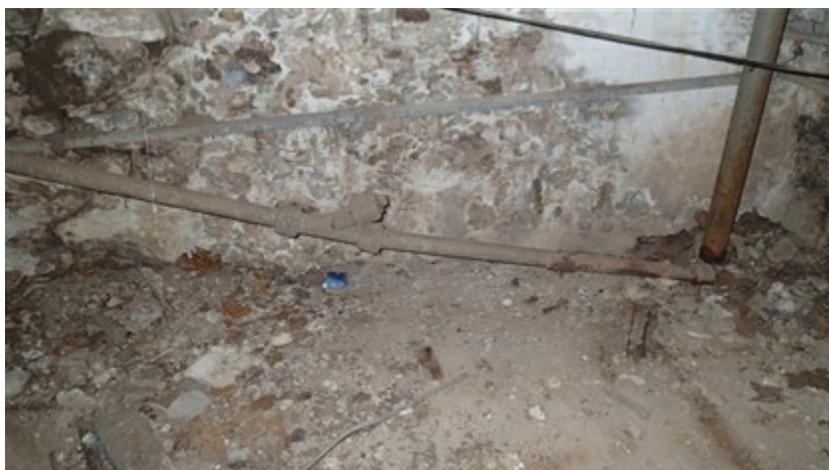
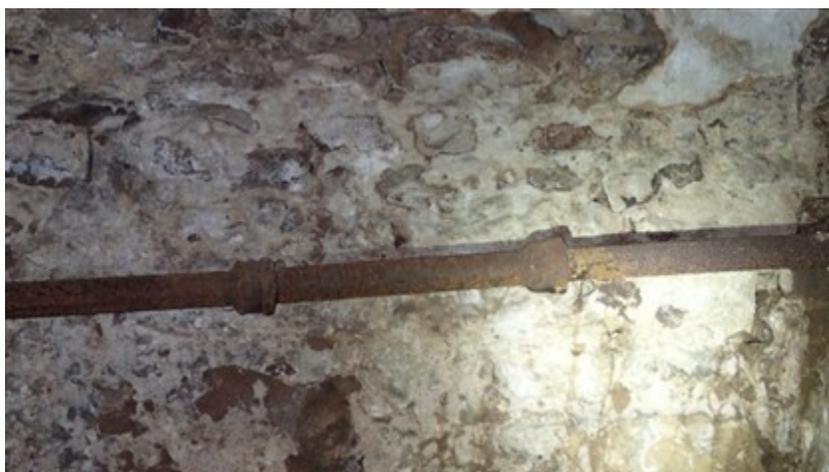
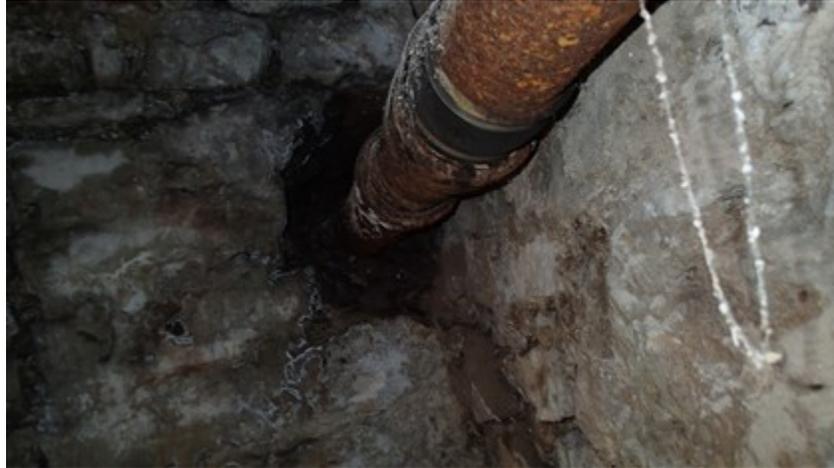
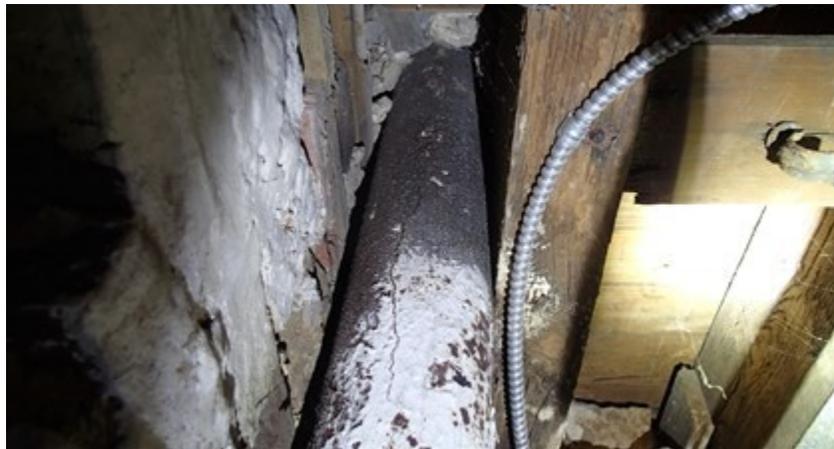
The cast iron drain, waste and vent piping several sections that have failed. This includes a section that has fallen down and extensive corrosion, with the most noticeable where it exits the foundation. There are also cracked sections. The drain, waste and vent pipe system likely needs replacement.

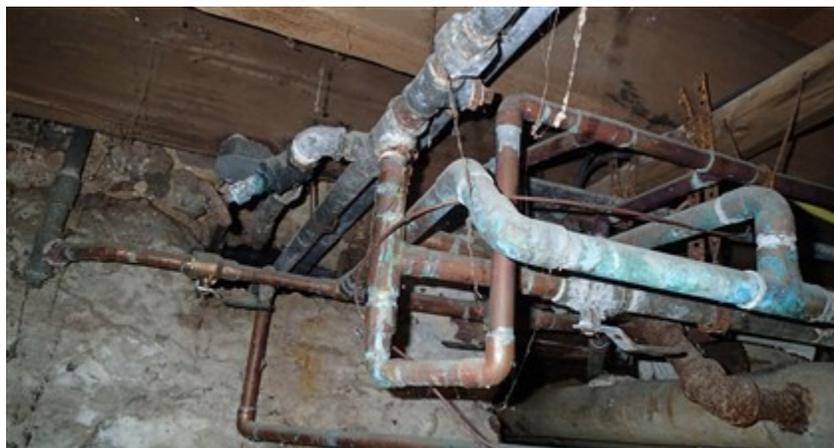
Copper and galvanized steel water supply piping are installed. Copper should not be directly connected to galvanized steel as corrosion forms between the two dissimilar metals.

There are other issues with the installation. The water supply and distribution piping likely needs replacement, as well.

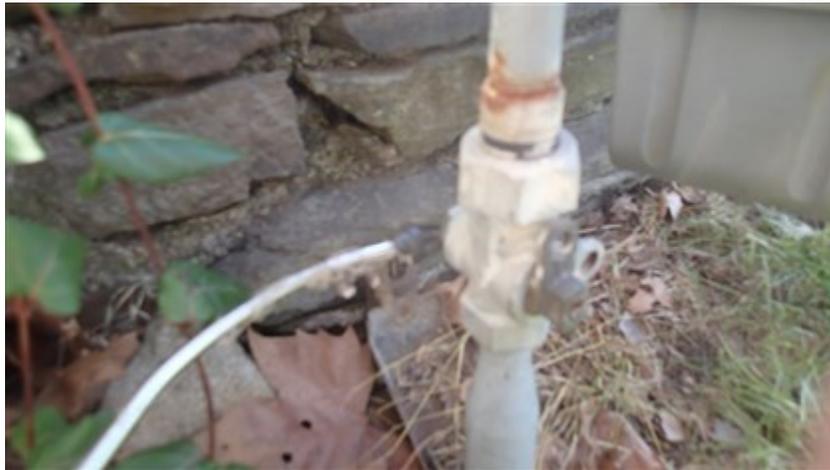
GAS LEAK There is a very strong odor of gas on the exterior near the meter. Using a combustible gas detector, I found the back of the shut-off valve leaking significantly. Some of the gas is entering into the basement as detectable levels were found there, as well. Contact the gas company for immediate repair.

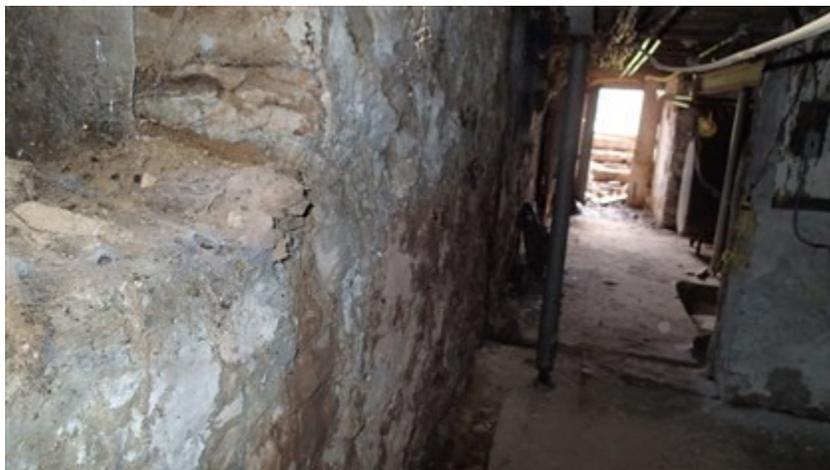
The foundation is constructed of stone. An area of the front wall has a slight inward bow. No repairs are needed at this time, but again, grading and gutter issues on the exterior should be corrected to divert all runoff away from the foundation.

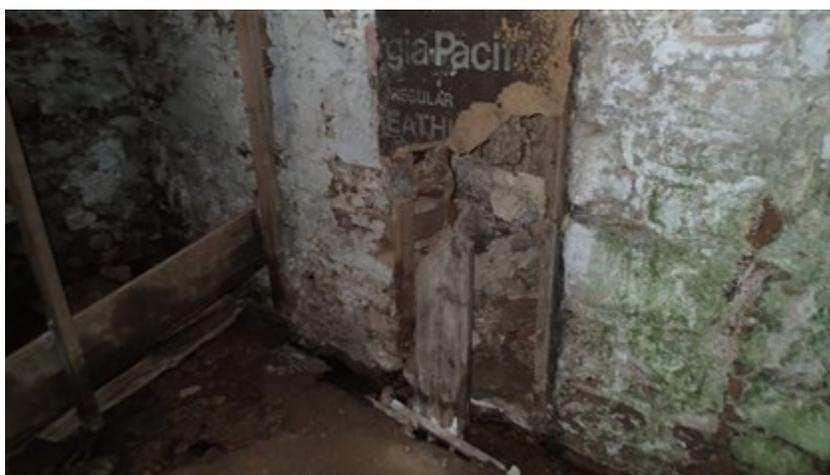
At the spring cellar section, there is a large void in the foundation that should be filled in.

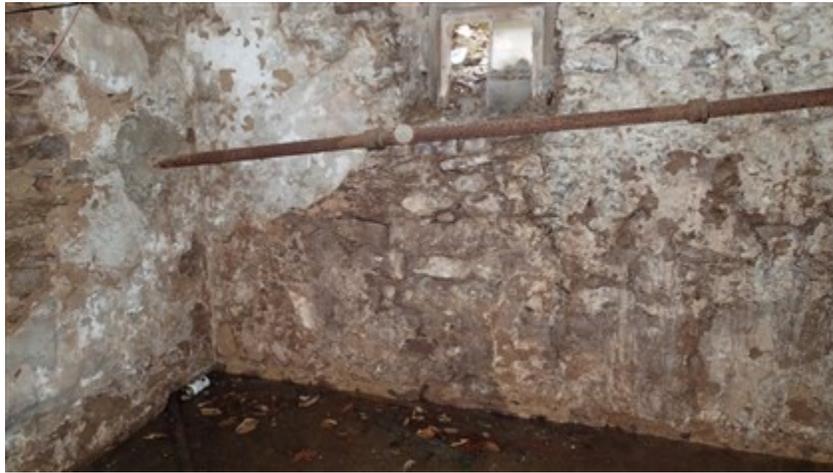
The interior of the foundation has a mortar coating applied. Patching the interior mortar coating should be considered perpetual maintenance. Some areas could use patching at this time. See: <https://historicbldgs.com/stonefoundations.html>

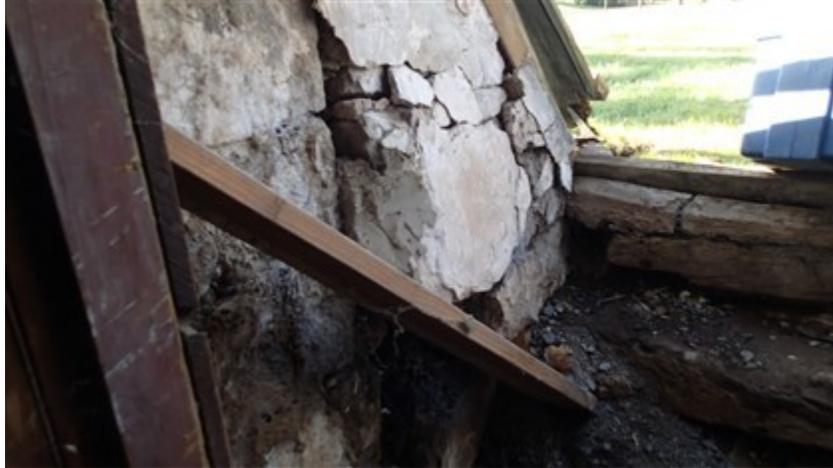
The outside entry steps and retaining walls on each side of the steps have significant dishevelment and gaps and need to be reconstructed.

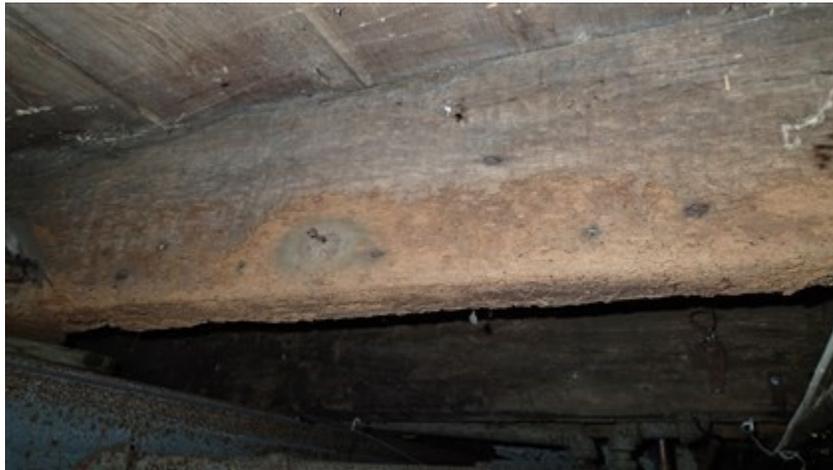
The floor structure above the basement consists of a mix of some hand-hewn and some milled floor joists. Tongue and groove sub-flooring is installed. There are many areas where there is deterioration on the surface of the wood, some powdering and some growth. All of this is likely due to an excessive amount of moisture in the basement as a result of standing water and moisture through the foundation.

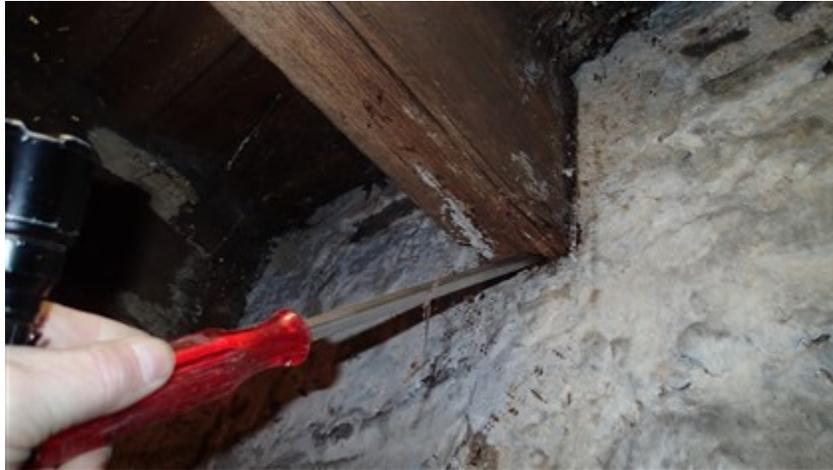
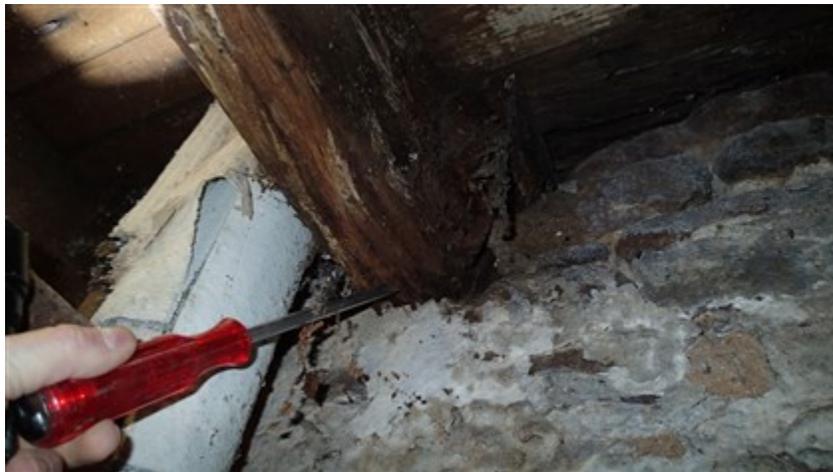
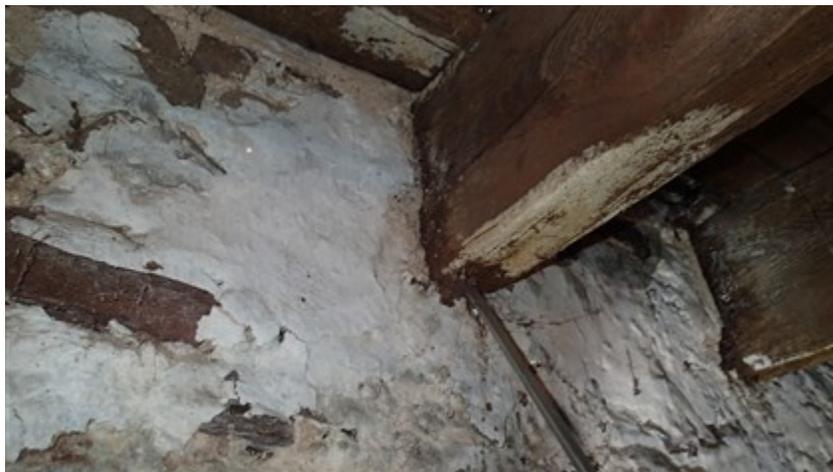
When I probed the damage, most of the joists do not need repair along their length. At the rear wall above the left spring cellar section however, the ends of the joists are deteriorated where they enter the foundation. A beam supported with posts should be installed to resupport the ends of the joists. (This type of repair was done in other areas of the basement.)

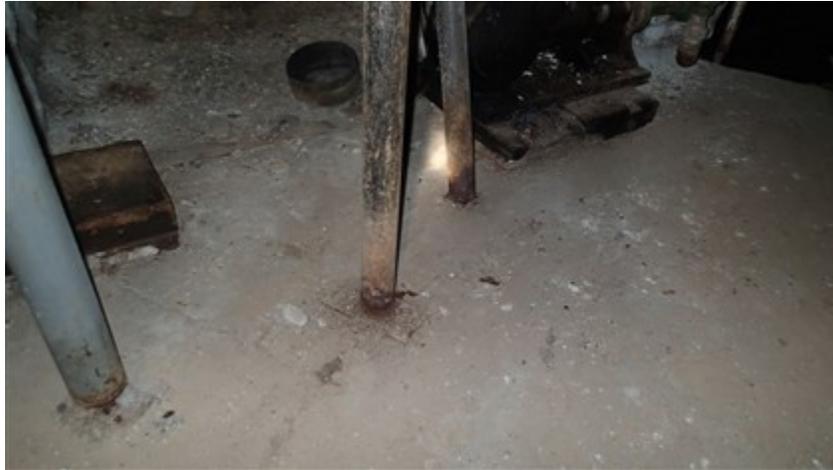
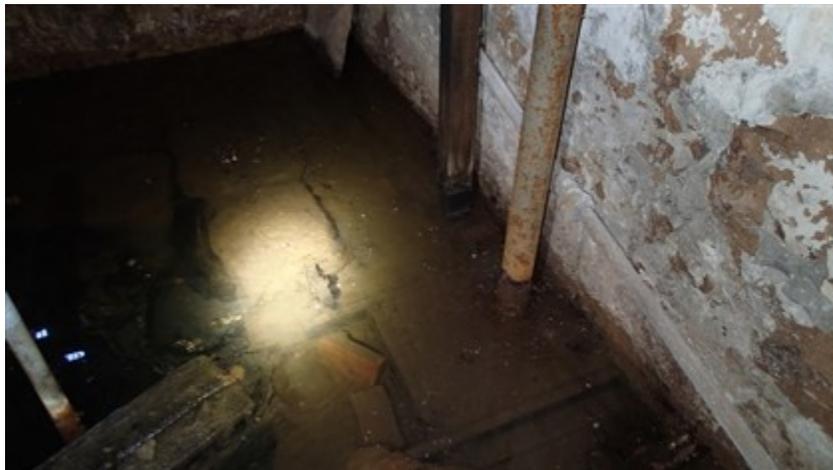
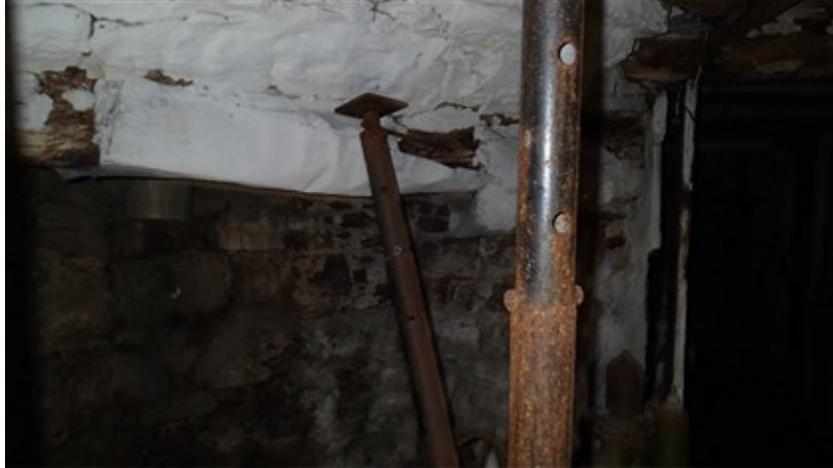
There have been other more central beams added, as well. There is corrosion to the bottom of the steel columns that support these added beams and some of the columns are only intended for temporary support. All the corroded posts should be replaced with posts approved for permanent structural support.

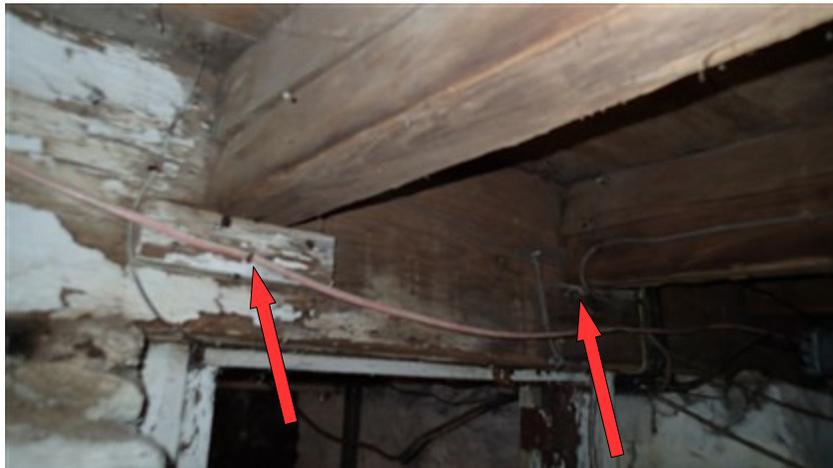
There are two floor joists that terminate at a door header that are only supported by thin, small blocks of wood. I recommend additional reinforcement to secure the ends of the joists to this beam properly.

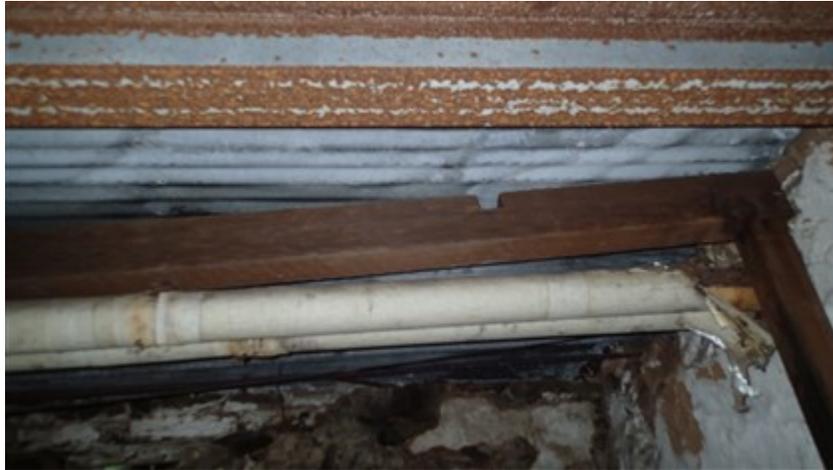
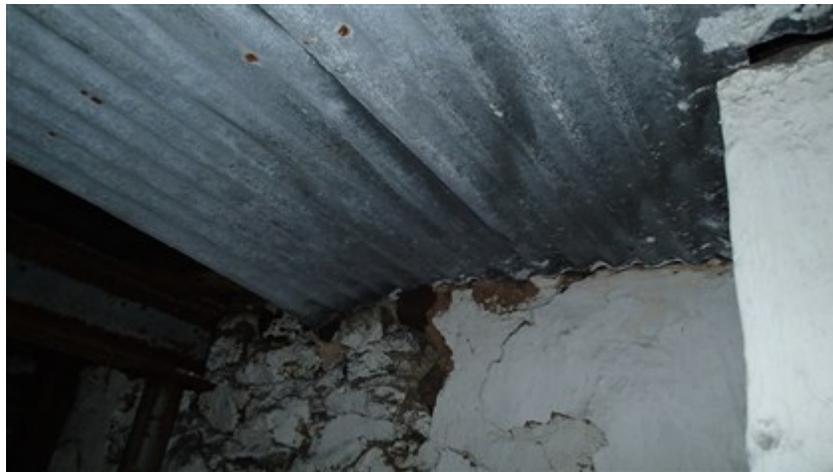
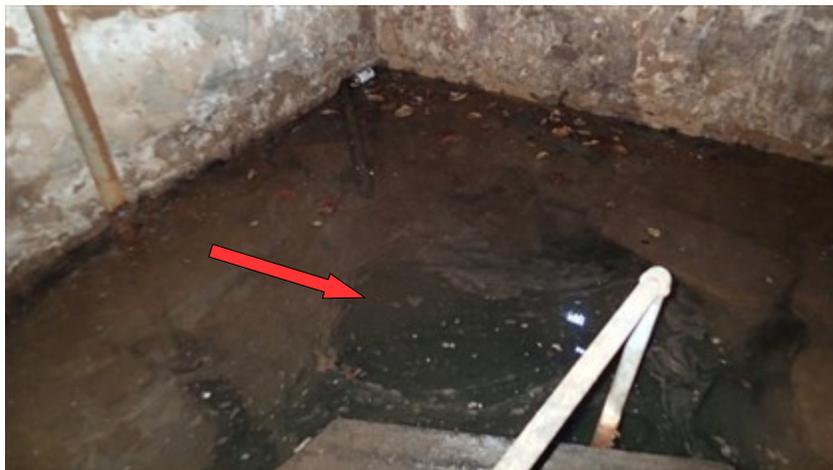
Some of the floor structure is not visible over the dug well area of the basement due to corrugated metal panels installed. I recommend these panels be removed and the floor structure above be evaluated.

With this much standing water, the moisture in the basement (and throughout the building) will continue to be quite excessive. I recommend making attempts to lower the water level and install a sealed and secured cover over the well for safety and to reduce the amount of moisture in the basement and building. If there is an artisan effect of this well, a relief piping system can be installed to discharge to the exterior well away from the foundation of the building.

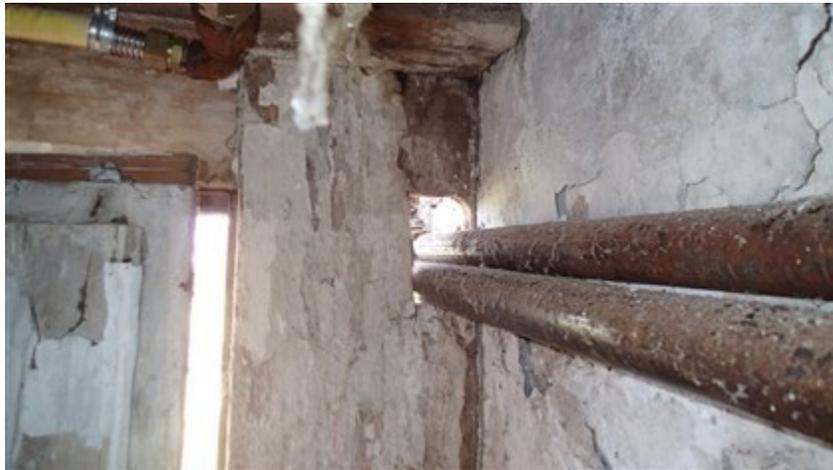
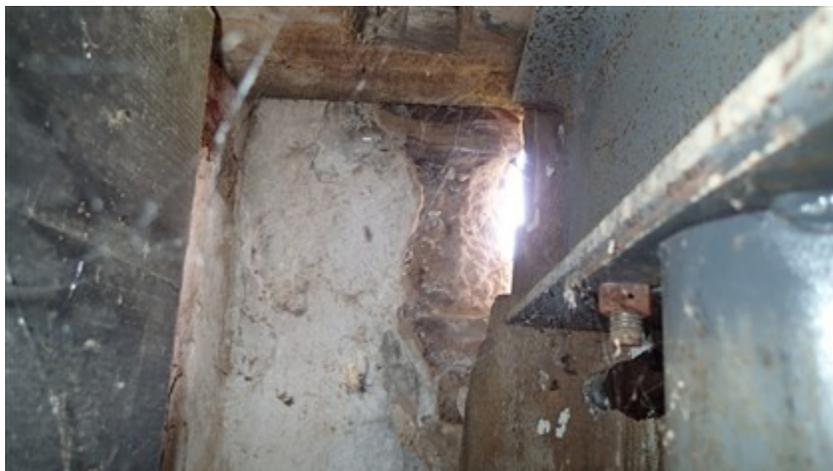
I found there are some large gaps in the left front corner to the exterior at the basement entry. (This is likely where the gas leaking from the main shut-off valve is entering the basement.)

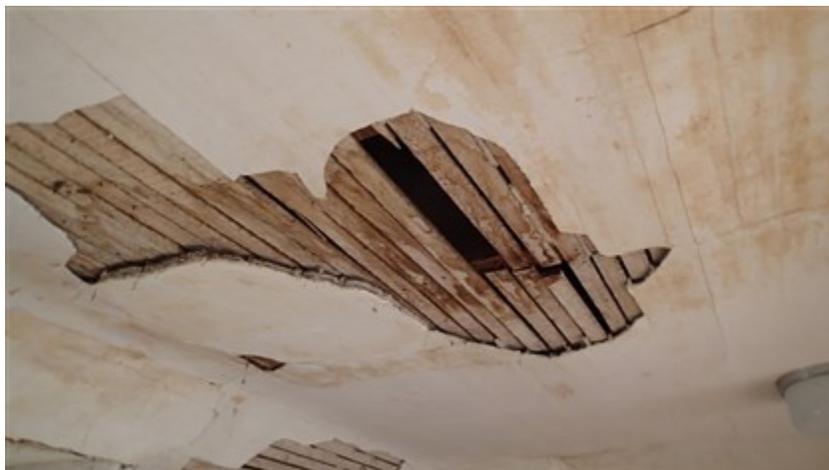
Very little of the roof structure is visible due to interior finishes and no access installed. I can only view a portion of the roof structure above the third floor through gaps where the plaster has been damaged.

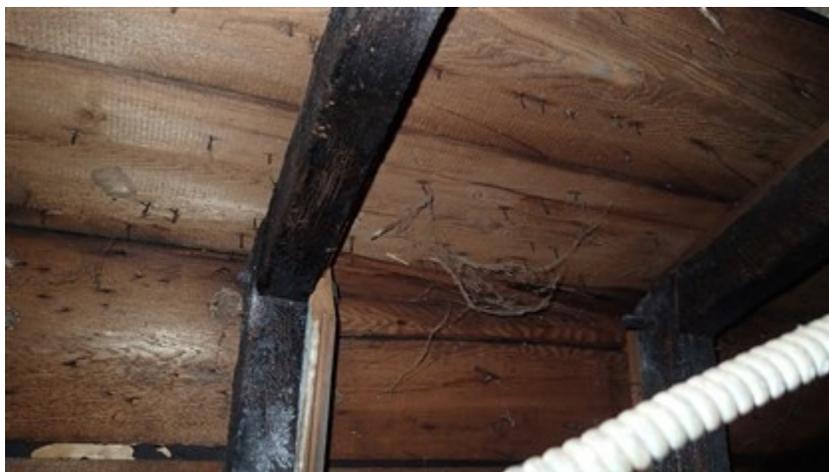
In one area, the visible roof rafters are very black. It is quite likely that a previous fire charred the rafters. Without access, I could not probe the charred wood to determine if any structural repairs or reinforcement are needed. Some thin boards nailed to the sides of the rafters would not be effective as any type of structural repair.

Have an access installed so the charred rafters and the rest of the roof structure can be evaluated.

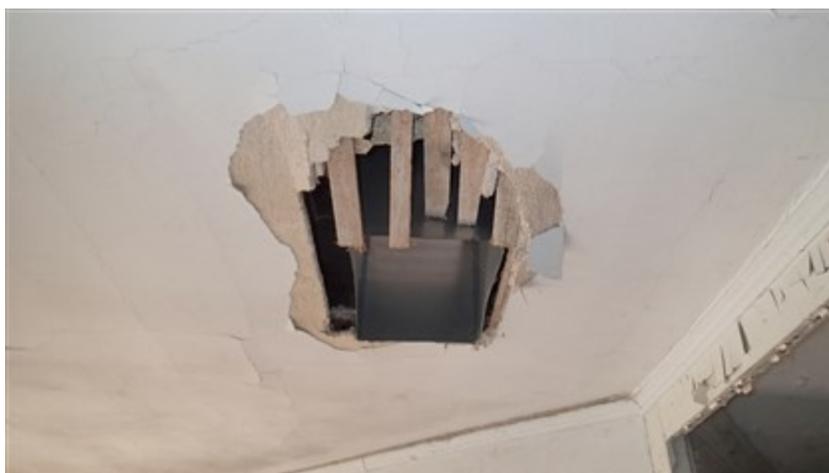
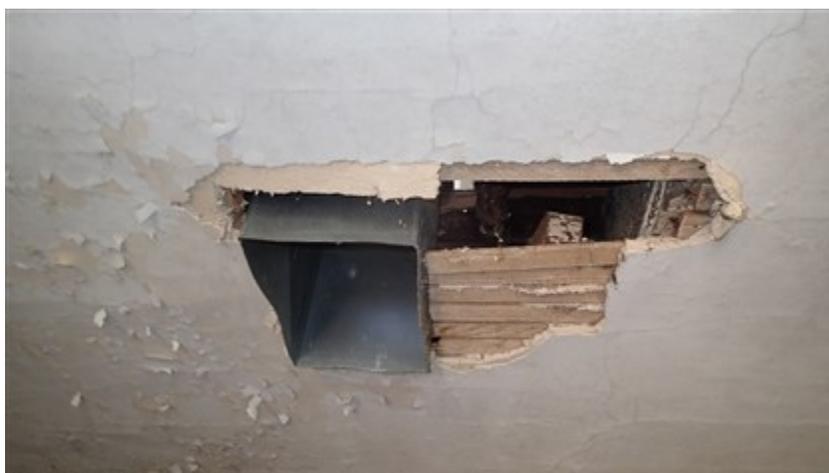
Plaster was originally used throughout the building. Wood paneling was added, likely about the time of the last addition. Significant damage was caused from pass-through vents being installed from the first floor ceilings through the floor. After having a proper heat distribution system installed, have all the damage repaired.

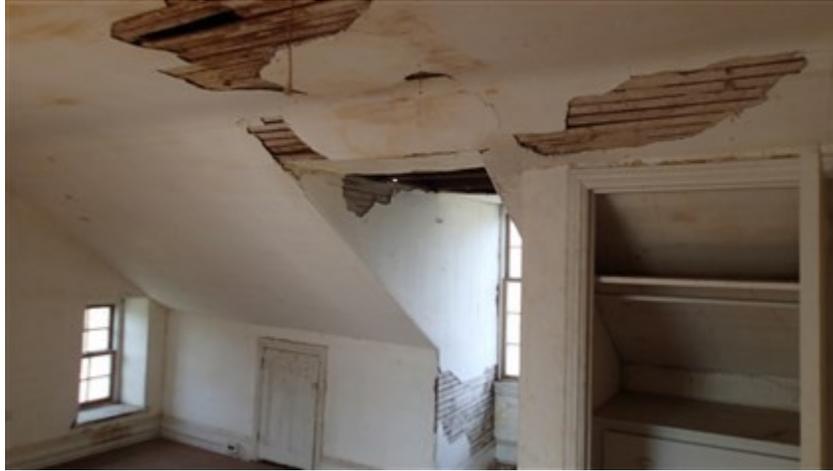
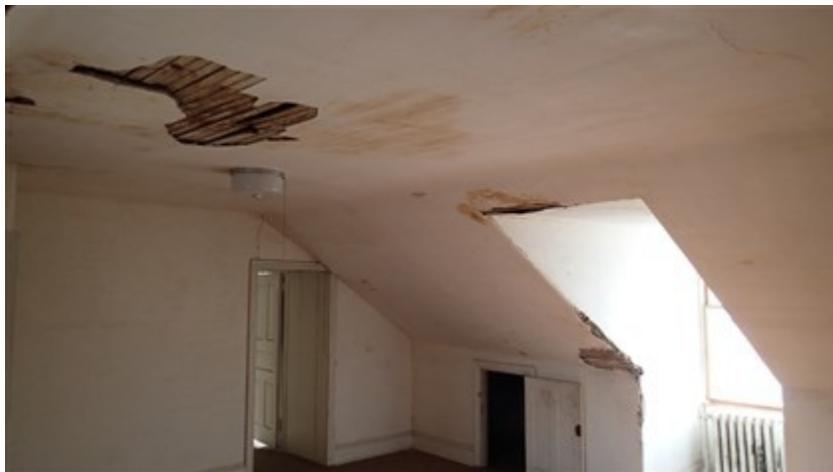
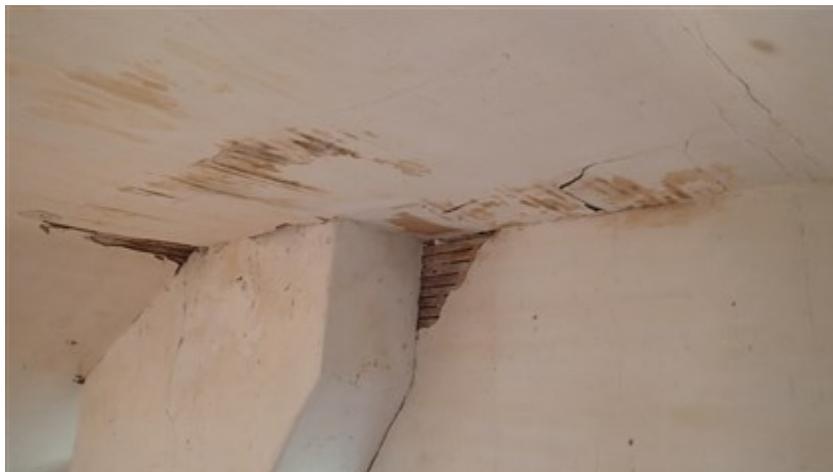
There is also other damage in some areas, mostly at ceilings. There are large stains from previous leaks. Some other staining is likely attributed to moisture condensing. There are also many cracks. There's peeling paint throughout. Have an experienced plaster repair contractor make all these repairs, as well.

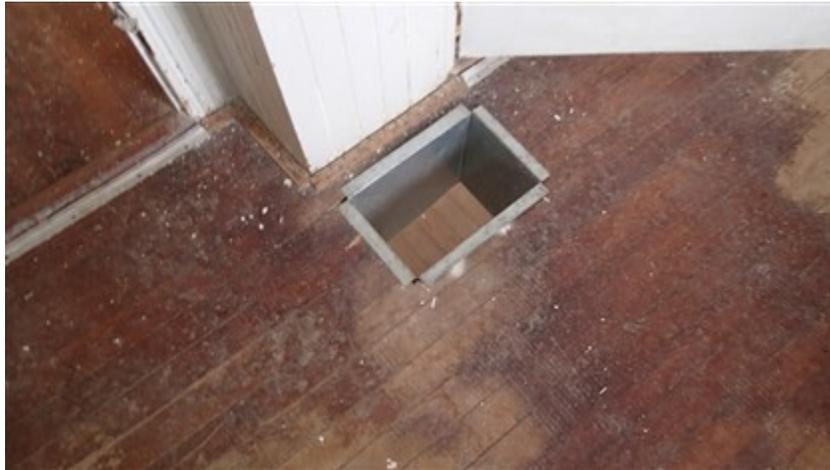
Tongue and groove type sub-flooring is installed. Again, there is damage from pass-through vents installed between the first floor ceiling and the second floor. This also created an unsafe openings in traffic areas, as well. Have all the damaged floors repaired.
