Inspection Report for
Claytor/Ingersoll House
Old Bethlehem Pike, Spring House, PA

CLIENTS: Lower Gwynedd Township

INSPECTION DATE: December 05, 2022

Inspector: William Kibbel III
Pa Compliant, NJ License #24GI00038400

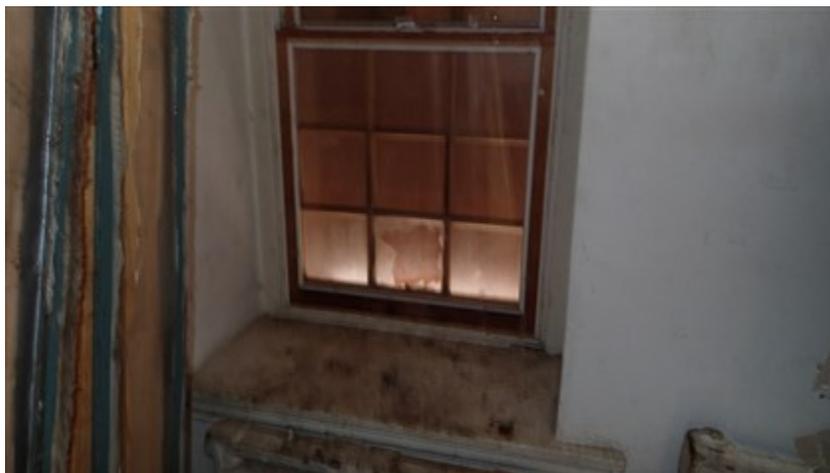
Several exterior windows are boarded over with plywood. There are many broken window panes. Have all the broken glass replaced.

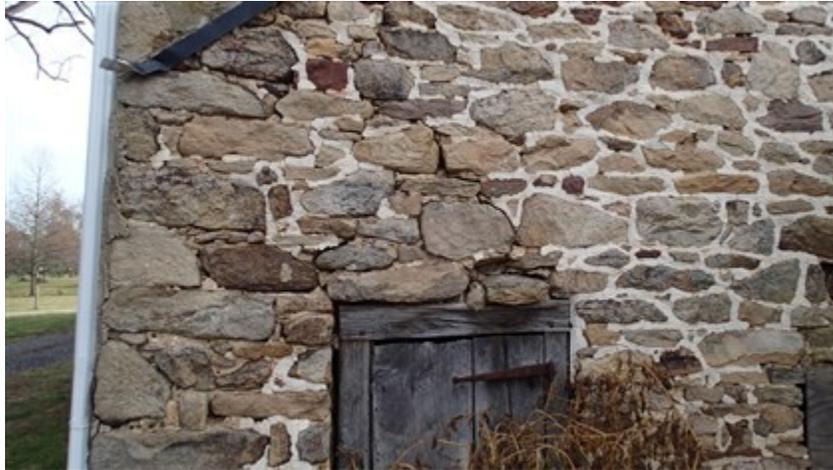
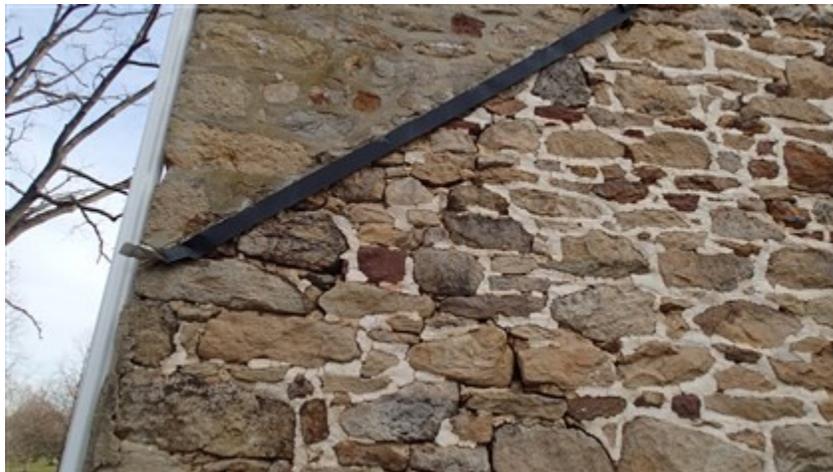
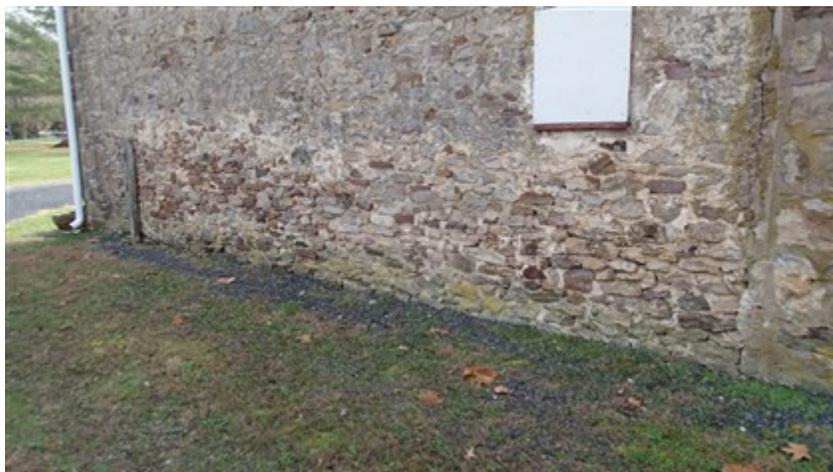
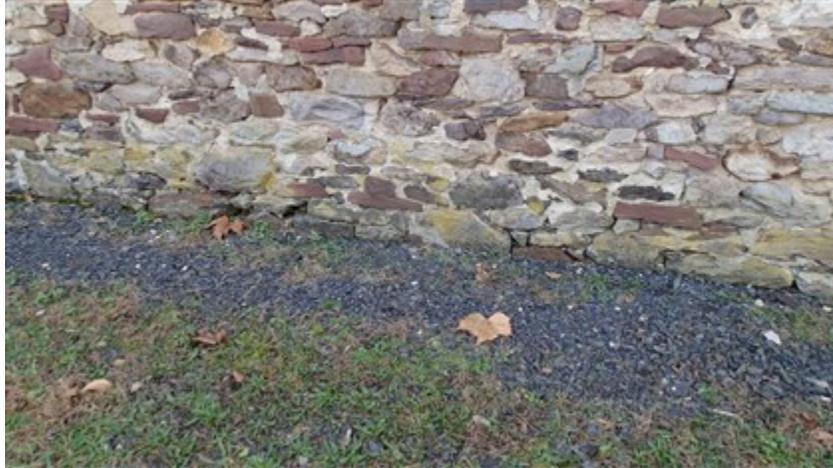
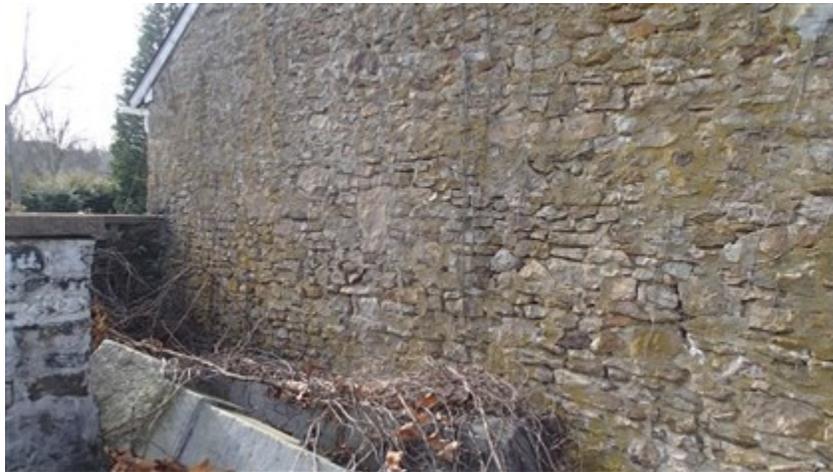
The frame of a small door has failed resulting in displaced stone work above. The frame/header needs replacement. The area above as well as other areas are in need of repointing in between the stone.

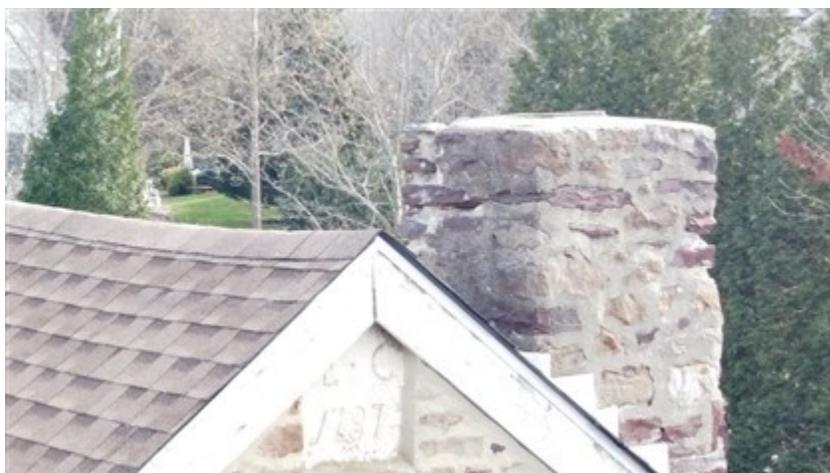
The asphalt shingles on the gable style roof are in satisfactory condition. The only ventilation is a cupola. This is very likely inadequate ventilation typically required for asphalt shingles. At the least, have a continuous ridge vent installed.

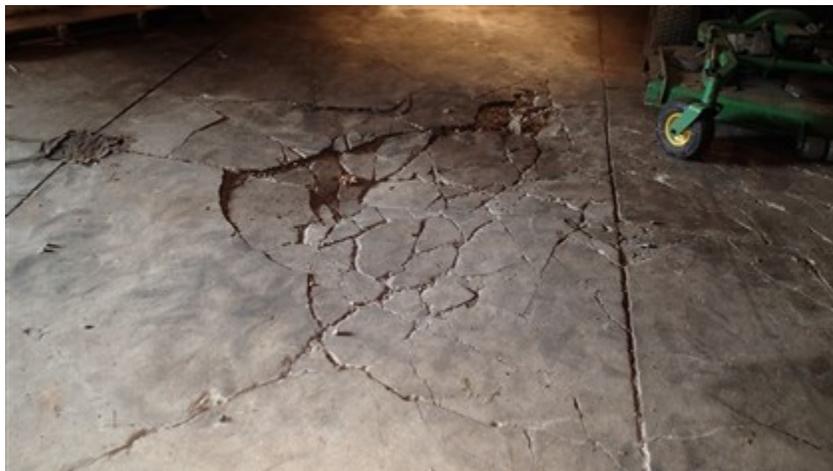
The concrete floor has many areas of cracks and some areas of considerable settlement. The older sections of the barn would originally just have a dirt floor and when the concrete was added, it may not have been well compacted and the concrete not properly reinforced.
