Inspection Report for
Claytor/Ingersoll House
Old Bethlehem Pike, Spring House, PA

CLIENTS: Lower Gwynedd Township

INSPECTION DATE: December 05, 2022

Inspector: William Kibbel III
Pa Compliant, NJ License #24GI00038400

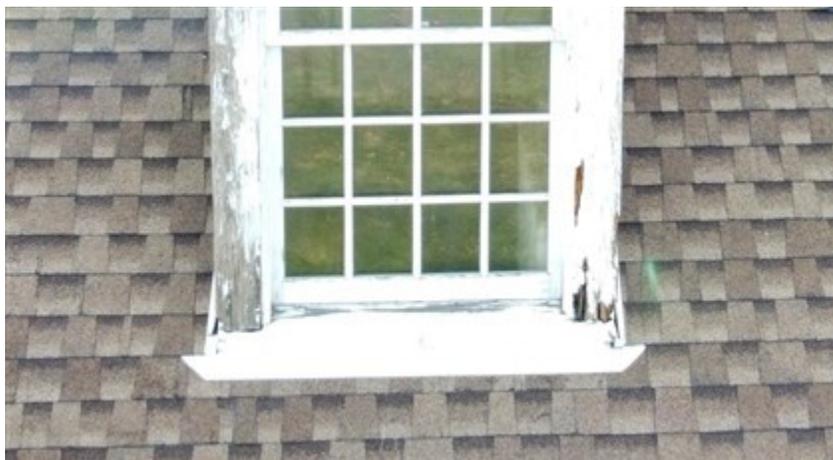
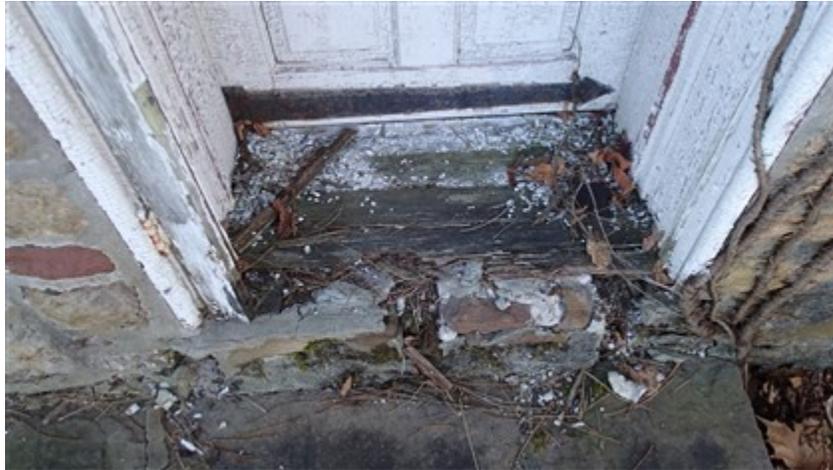
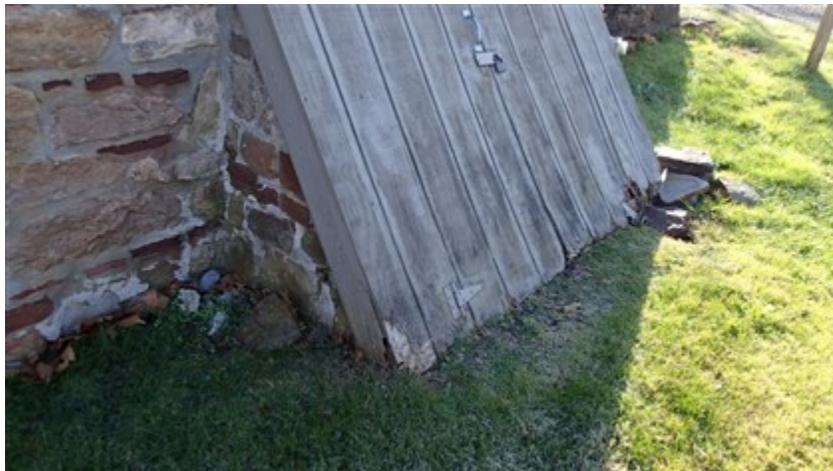
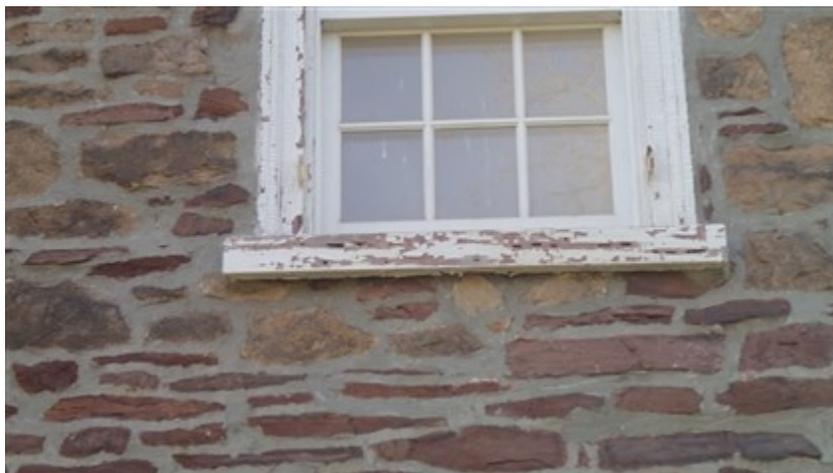
The trim around windows and doors, roof edges and overhangs are painted wood. There are areas of deteriorated wood that needs to be removed and replaced.

Some of the wood has many holes, likely from carpenter bees.

Horizontal wood trim projecting beyond the walls should have a head flashing installed to divert water from entering behind.

There are many areas where scraping, priming and painting are needed at this time. Have an experienced carpenter remove and replace all damaged and deteriorated wood and then scrape, paint and caulk where needed.

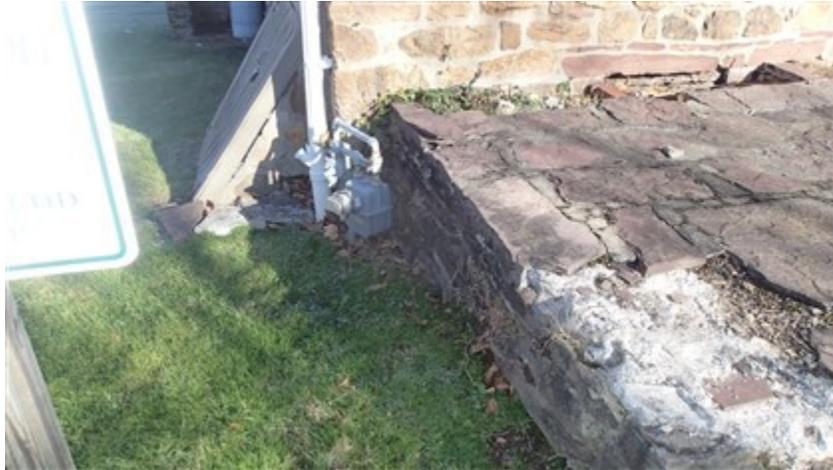
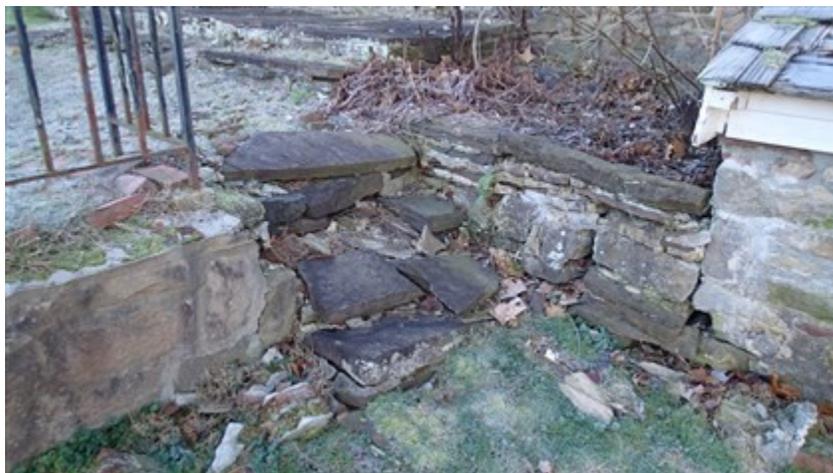
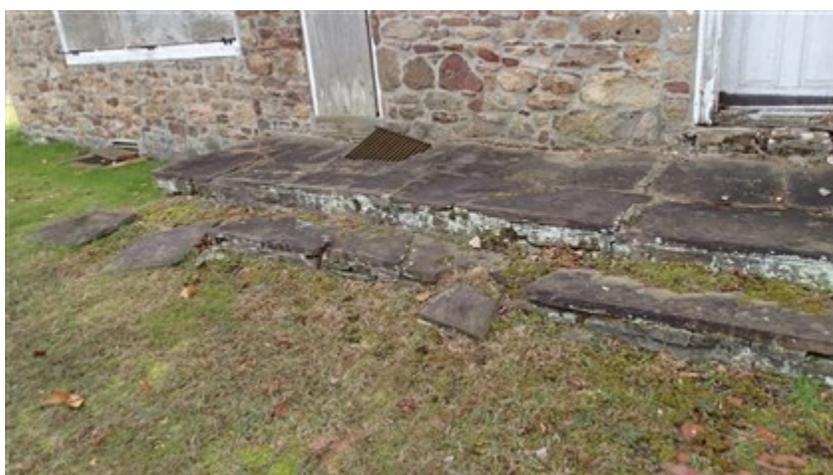
The front and rear stone patios need repair. Missing and disheveled stones at the patios and steps need to be reinstalled and the stone work repointed.

I also recommend guard rails be installed at the end of the patios where they terminate well above grade. One of the exterior stone steps that should have a hand railing installed.

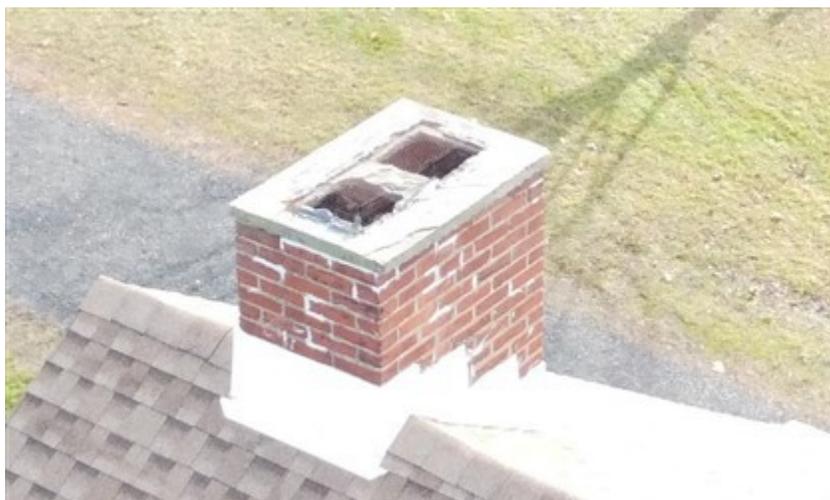
There are no caps installed over the flues. Screens do not keep water out. Have proper caps installed.

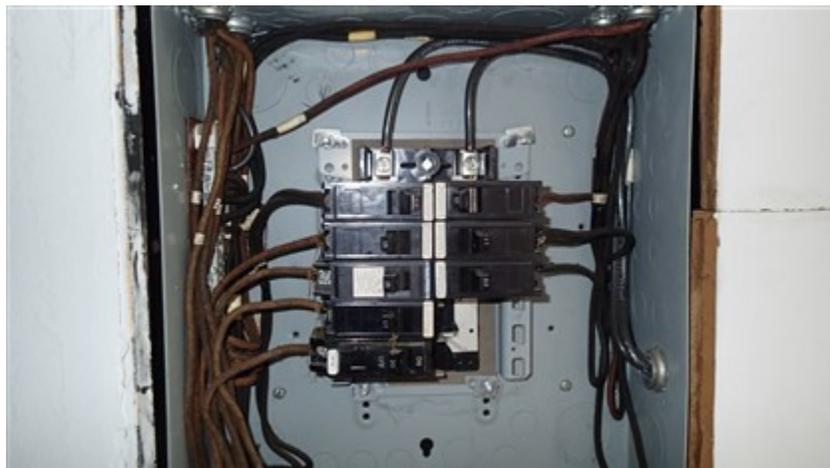
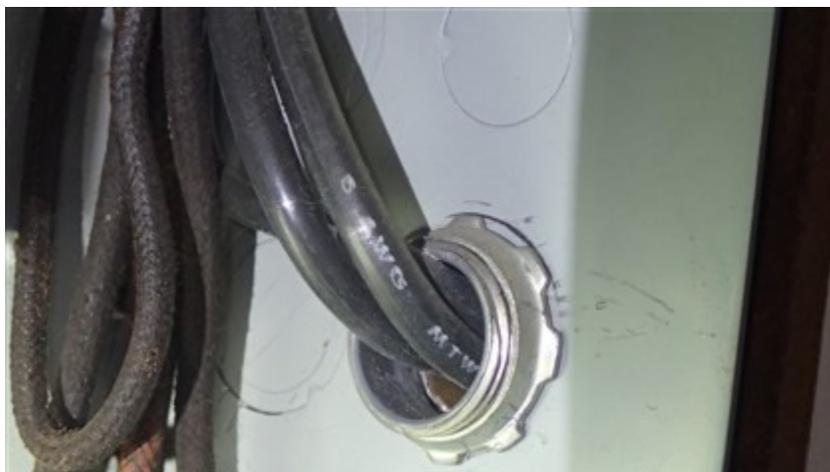
There is a subpanel in the upstairs hallway. None of the circuits are grounded circuits and there is no ground conductor installed from the main panel to this panel.

One of the breakers has two circuits installed. The terminal on this breaker is intended for only one conductor.

There are very few circuits and outlets throughout the building. I recommend additional grounded circuits and outlets be installed throughout the building and GFCI protection installed so all exterior, bathroom and basement outlets are protected. Any old, abandoned wiring should be removed.

Have a licensed electrician make all electrical repairs, corrections and installations needed for safety.

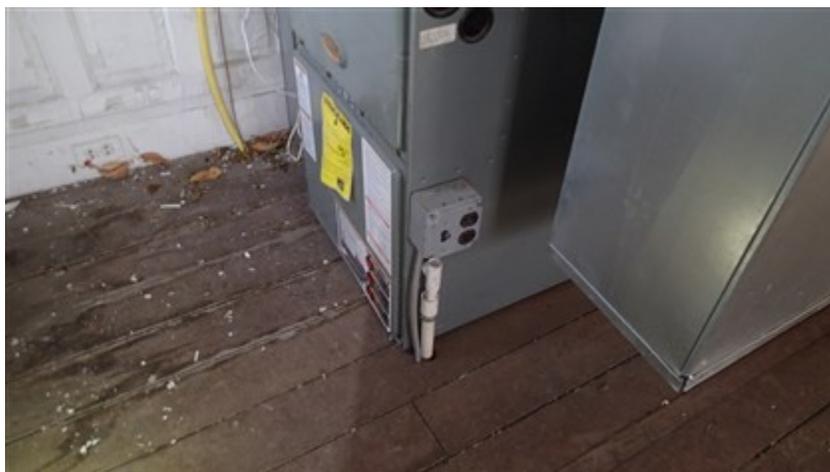
1. The furnace was placed on a finished wooden floor on the first level. Since this is a condensing furnace, there should be a condensate overflow pan and drain system installed.

2. The primary condensate just drains into the basement instead of a proper, approved location for the discharge.
3. The electric cable to the furnace is not properly installed, secured or protected.
4. There is only one single supply from this furnace rather than distribution to individual rooms.

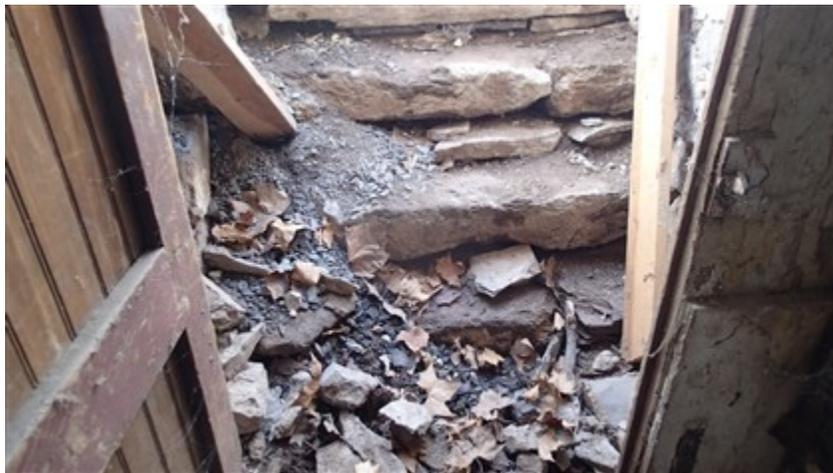
The outside entry steps and retaining walls on each side of the steps have significant dishevelment and gaps and need to be reconstructed.

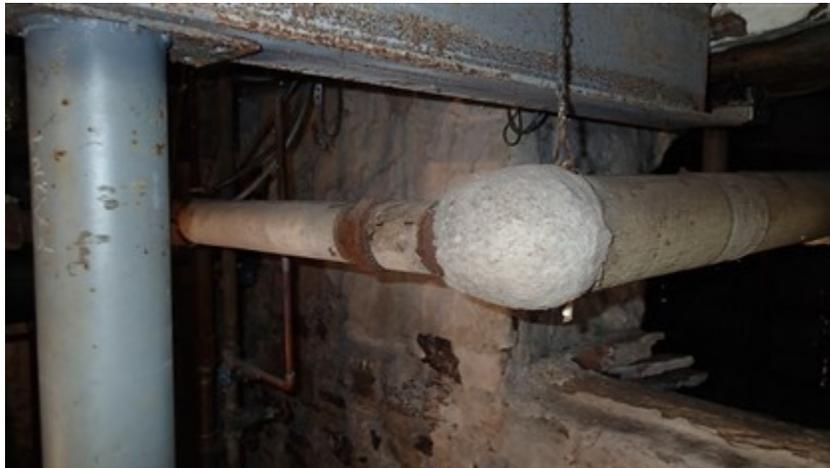
In the basement some of the pipe insulation is fiberglass, but on some sections, it is quite a bit older and likely contains asbestos. There are insulating materials on some abandoned duct work on one of the water tanks that was connected to the boiler and some laying on the floor that also likely contains asbestos.

Consult with an asbestos abatement contractor at this time. For information on reducing the risk of exposure to asbestos fibers, please read: www2.epa.gov/asbestos/protect-your-family#whattodo.

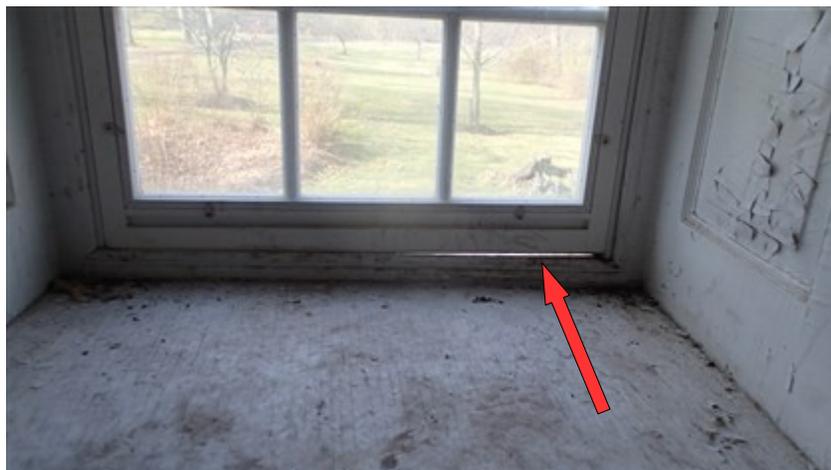
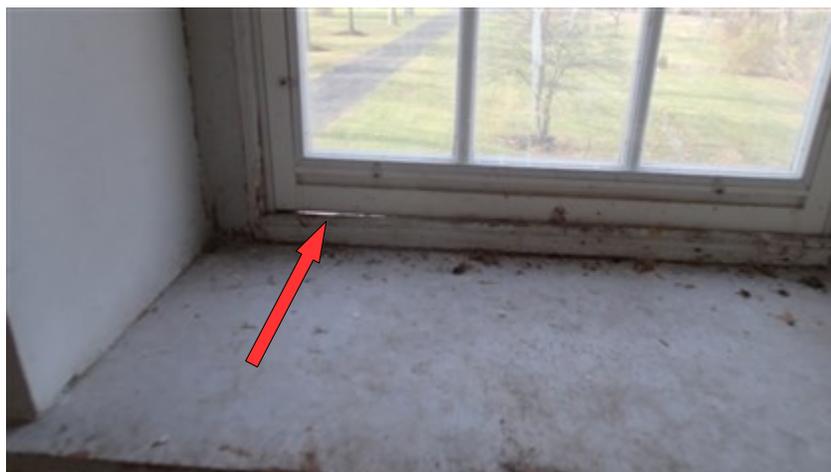
Several of the newer windows are incorrectly installed in the window openings resulting in gaps. Have the windows properly installed where needed.

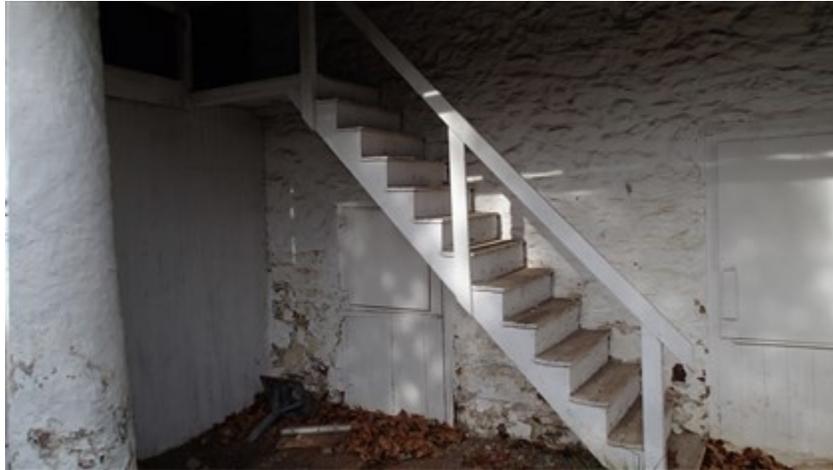
There are exterior stairs to a second level room. Additional support is needed to the stringers. Have a proper guard rail and a graspable hand rail installed.

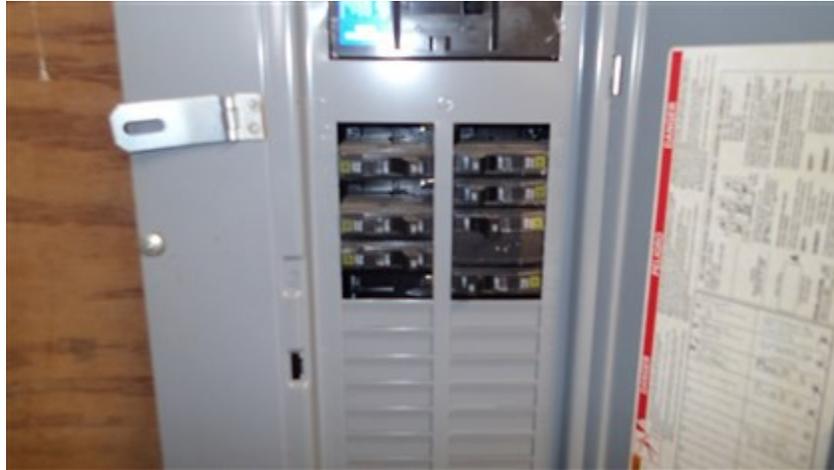
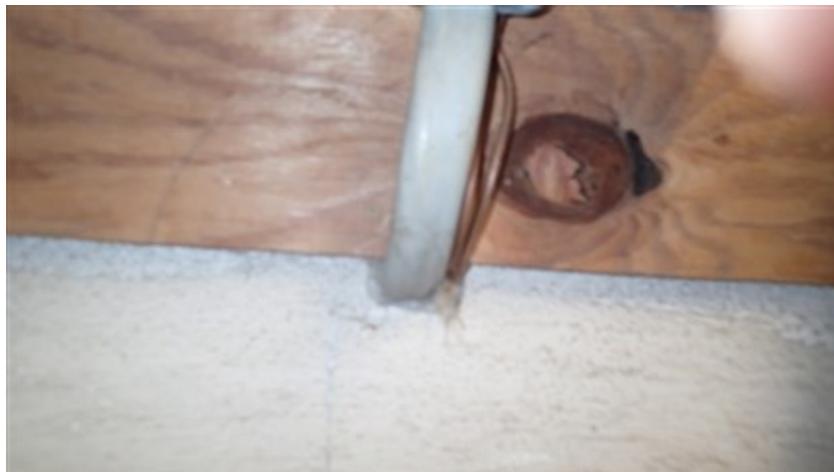
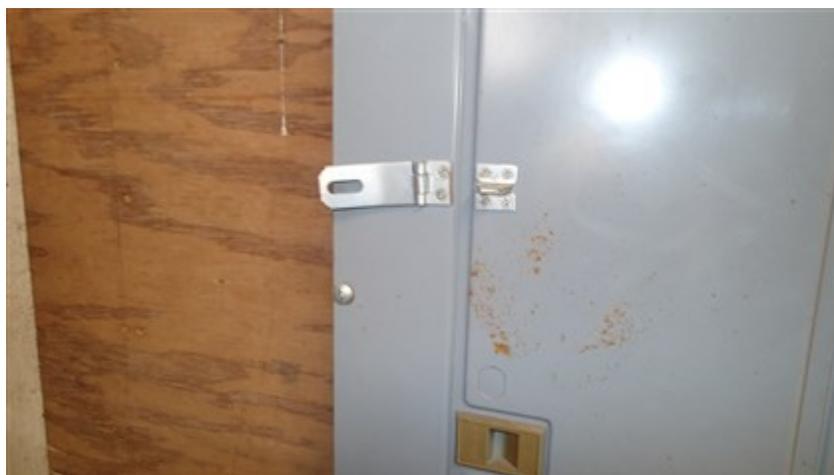
There is a 200-amp panel in the left front corner room. There are openings at the face of the panel that needs filler plates installed for safety.

A lock hasp was installed on the panel that should be removed.
